TECHNICAL SERVICE BULLETINS

2/24/89

TECHNICAL SERVICE BULLETIN

ERROR CODE INFORMATION FOR ALL SOFTWARE THRU 4.00.00

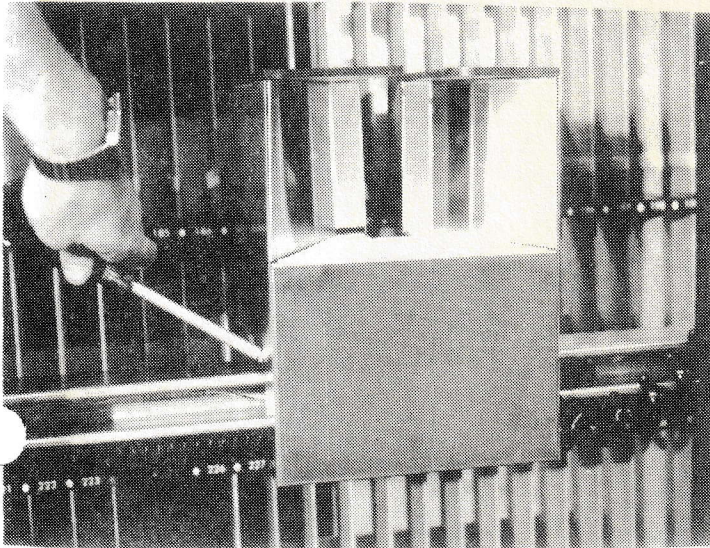
< 1 >

(a) Use Diagnostic controls to move transport to convenient position in LEXAN DOORWAY. Turn off main power switch. Open door.

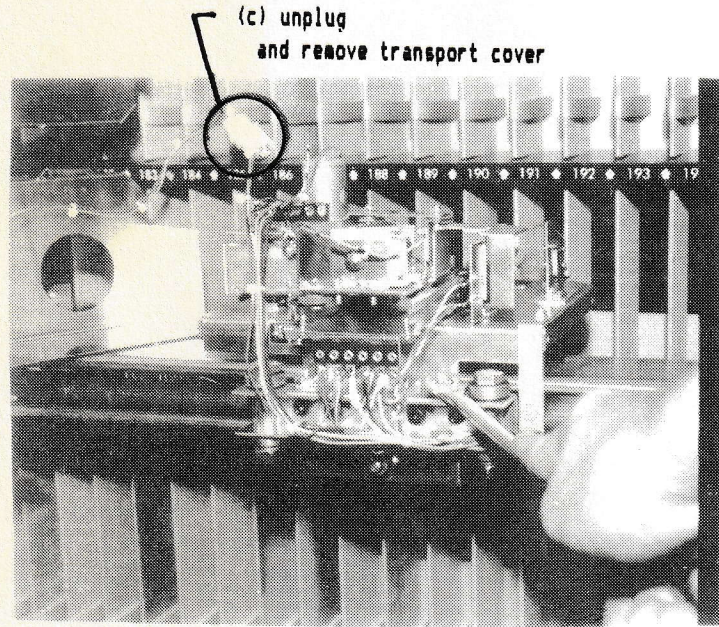
< 2 >

(b) Remove 4 screws holding transport cover

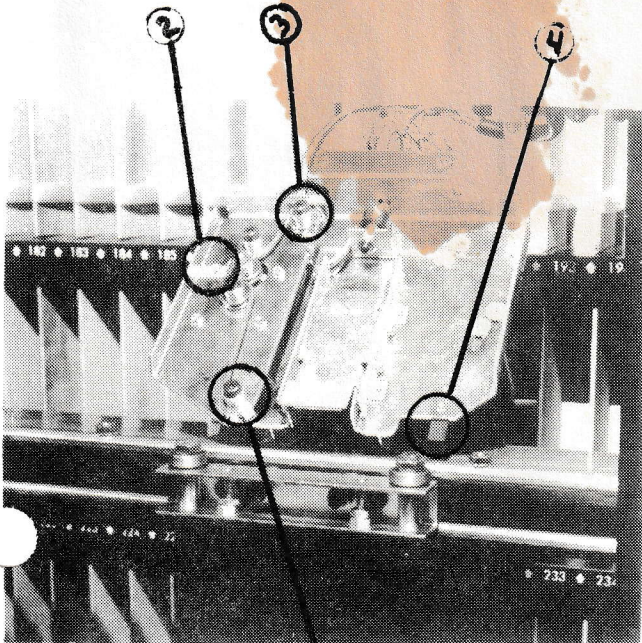
< 3 >

(c) unplug and remove transport cover
(d) Use 7/16" wrench and remove 2 nuts as shown. Note: two wrenches may be necessary one to hold bolt head underneath

CAUTION: SINCE THE TRANSPORT ASSEMBLY FITS LOOSELY ON THE BOLTS (SEE D #2) YOU MAY FIND THE X POSITION OFF A LITTLE AFTER RE-ASSEMBLY; WHEN TESTING A PICK-UP; IF SO ADJUST BY LOOSENING AND TWISTING TO RE-ALIGN.

When re-assembling watch wire (c) photo #2. Coil around motor and make sure it does not interfere with mechanism operation. Make sure nuts (d) photo #2 are tight. Make sure plastic interrupter is straight as it must enter optical sensor to find (x) home position.

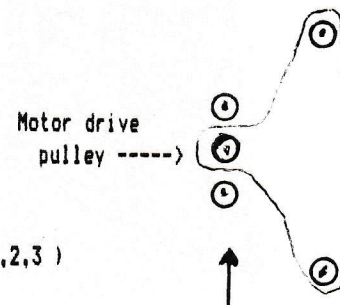
(e) Remove top mechanism and turn upside down as shown and be careful of wires and plastic interrupter (photo #3 detail (4))
If belt jumped off it may be necessary to force the belt back on between the belt guards and their respective pulley's. Then bend belt guard fingers closer to belt.. see belt path diagram.

Belt guard fingers (photo #3 details 1,2,3)

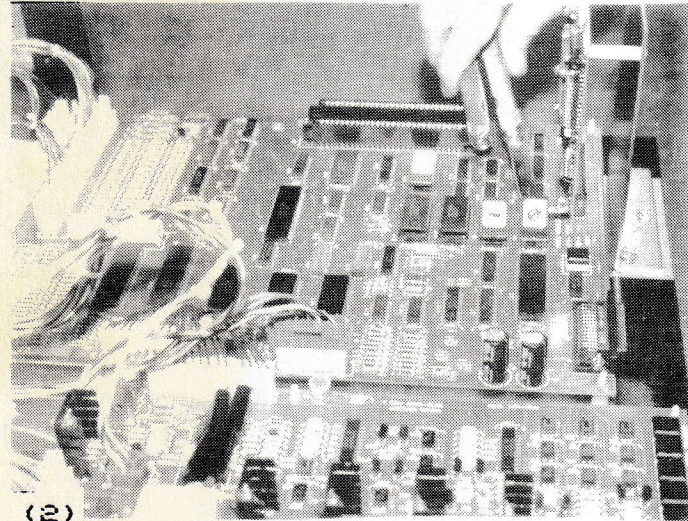
(2)

PROM 2 IS SHOWN BEING REMOVED FROM IT'S SOCKET.
METHOD:

SLIP A KNIFE BLADE UNDER ONE END OF THE PROM AND
PRY GENTLY BUT NOT ALL THE WAY. REPEAT ON THE OTHER END. GENTLY
ROCKING THE PROM CHIP OUT OF THE SOCKET.

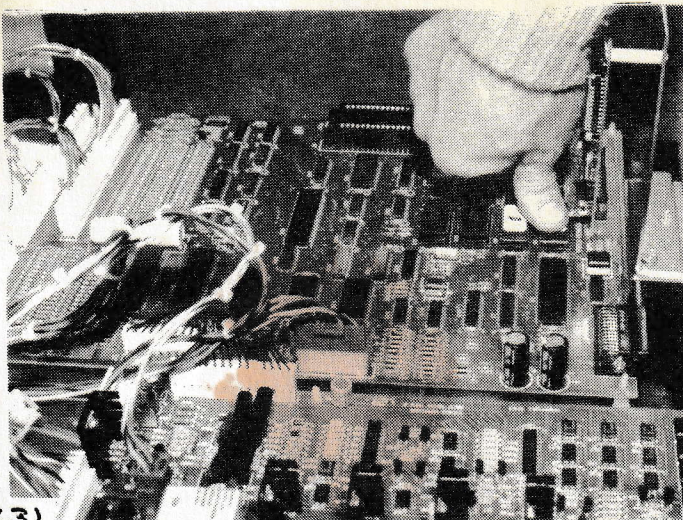
(3)

POSITION NEW PROM 2 WITH KNOTCHED END TO THE LEFT (POINTING
TOWARDS THE MOTOR CONTROLLER CARD) INTO THE SOCKET MAKING SURE
ALL PINS ALIGN WITH THE SOCKET HOLES. THEN PRESS IN FIRMLY WITH
YOUR THUMB.

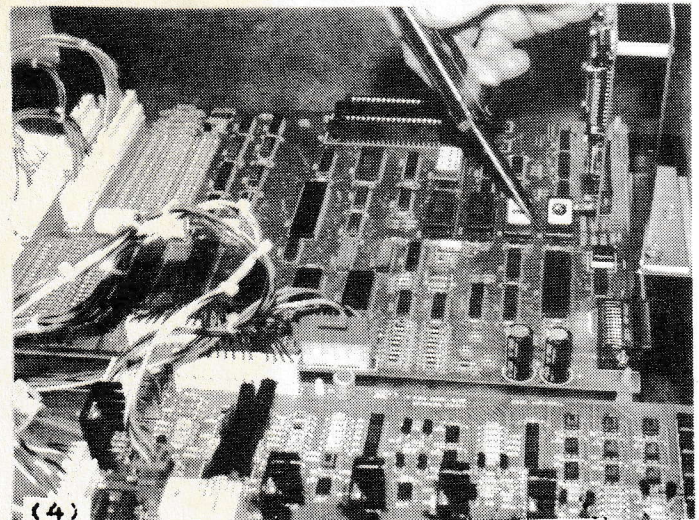
(4)

CHECK ALL AROUND THE PROM TO MAKE SURE NONE OF THE
LEADS WERE BENT OR ENDED UP OUTSIDE OF THE SOCKET.

IF THE MONITOR OR PRINTER FAIL TO POWER UP
SHUT THE MACHINE DOWN.....
AND CALL VIDEO VENDOR IMMEDIATELY
(312) 982-0440

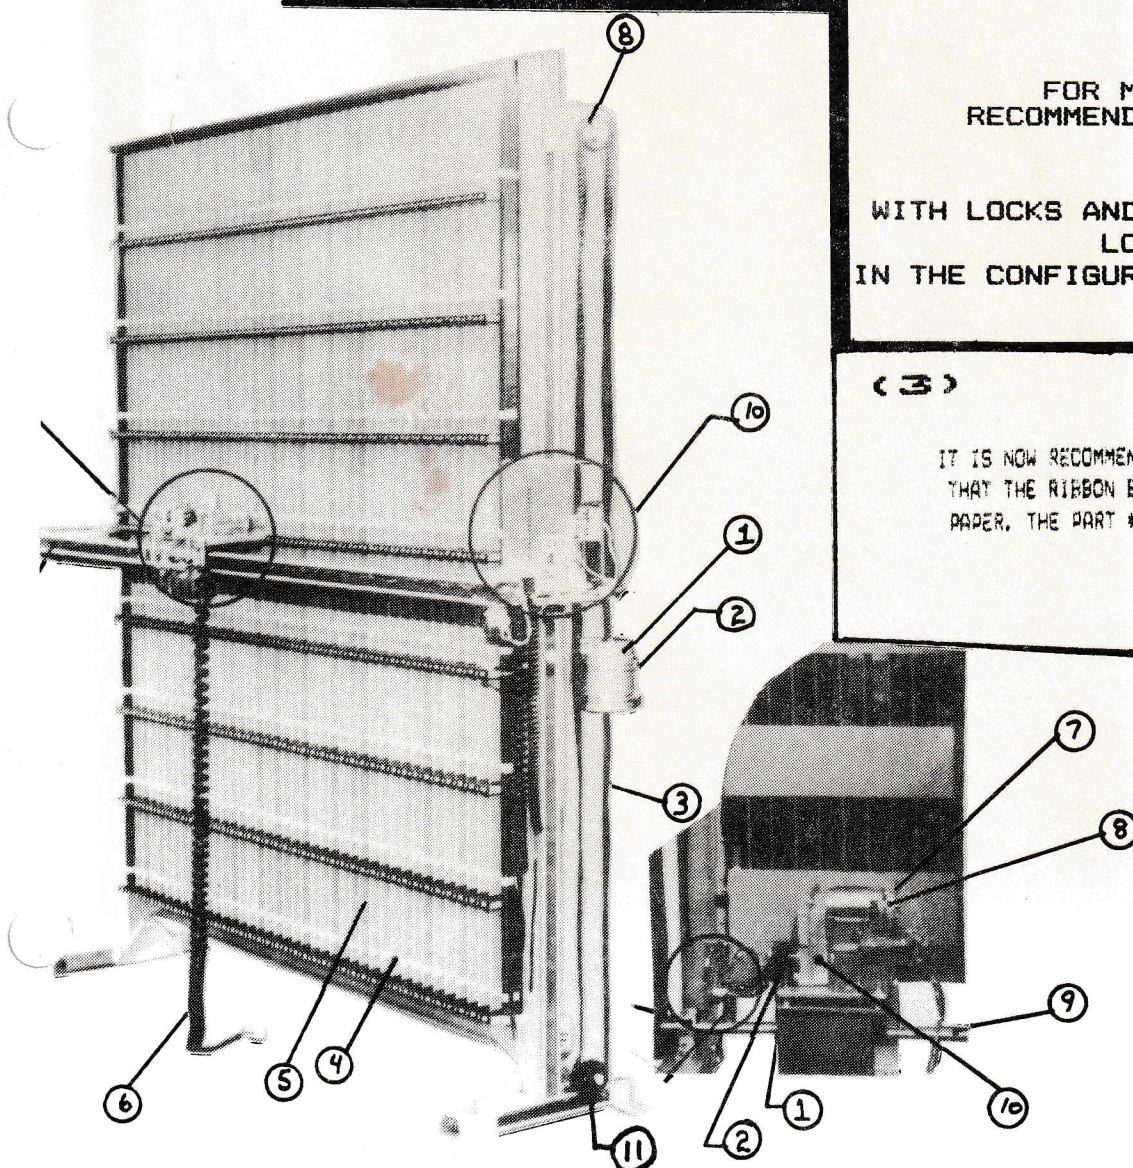
THE SET SCREW MAY COME LOOSE FROM SHIPPING OR OTHER VIBRATIONS ALLOWING THE SPROCKETS TO FALL OFF OF THEIR RESPECTIVE SHAFTS.

SHAFT (9) IS THE SHAFT WITH 3
SPROCKETS ON IT, ONE AT EACH
END AND ONE BY THE MOTOR.
THERE IS ALSO ONE SPROCKET ON
THE MOTOR TO BE CHECKED.

SPECIFICALLY CHECK SPROCKET
PART #'S. (11), (1), (2).

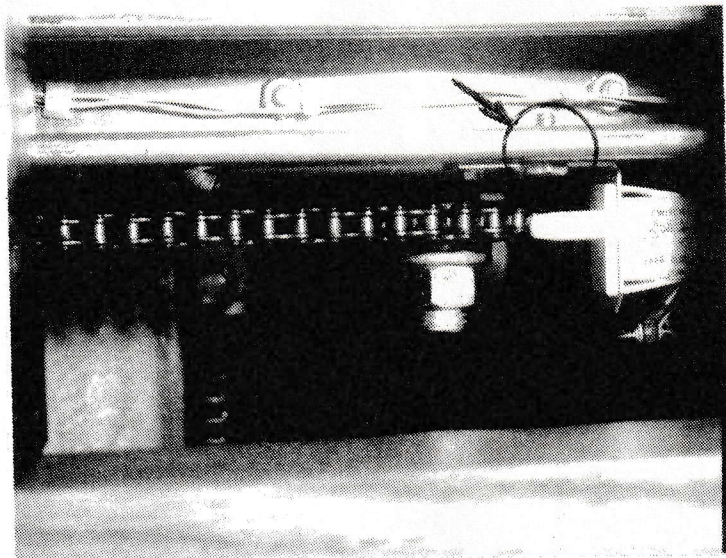
IF THE BOLTS ARE MISSING IT WOULD ALLOW THE TAPE TRANSPORT TO
MOVE TO FAR RIGHT OR LEFT UNDER MANUAL CONTROL OR DURING A
MACHINE MALFUNCTION....SO THAT THE X-ENCODER COULD BE DAMAGED OR
THE OVERTRAVEL LIMIT SWITCHES BROKEN.

HORIZONTAL CARRIER RAISED TO ACCESS
DOOR HEIGHT THIS IS VIEW THRU DOOR.

IF YOUR BOLT AND NUT IS MISSING PLEASE CALL IMMEDIATELY AND WE
WILL SHIP THE CORRECT PART OR ADVISE A LOCAL SUBSTITUTE.

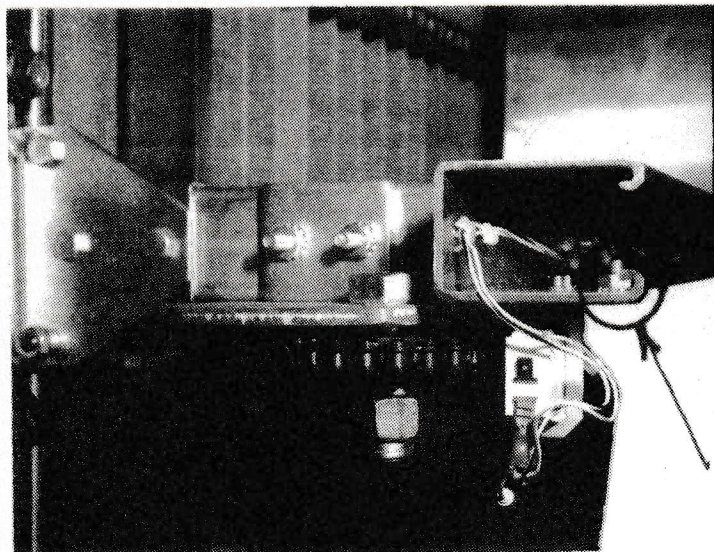
DOOR OPENED ON THE LEFT SIDE
VIEW OF END OF HORIZONTAL
CHANNEL

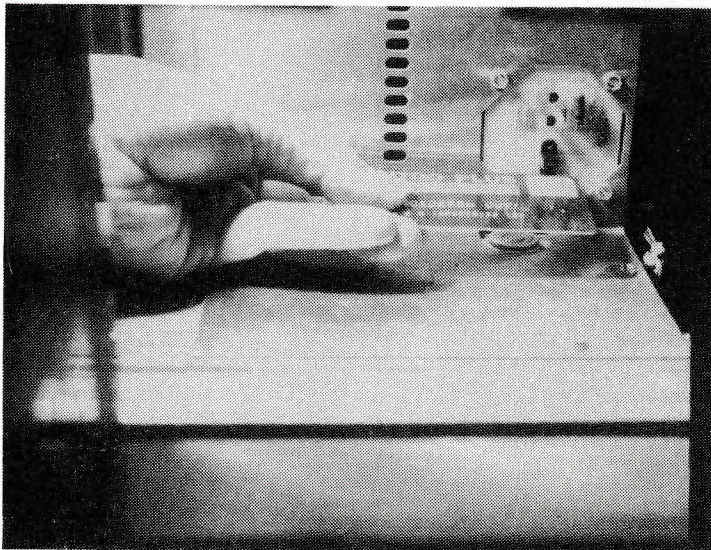
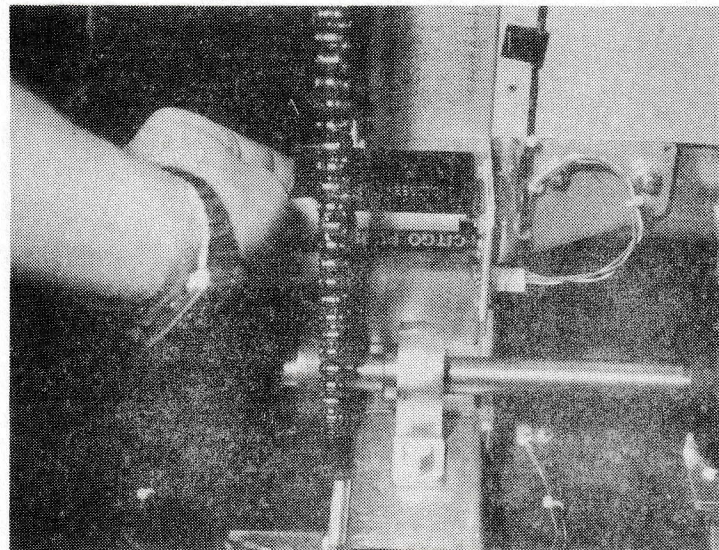
PHOTO (3)

testing x-home

IF THE ENCODERS DO NOT RESPOND TO THE CARD TEST THE PROBLEM COULD BE A DEFECTIVE ENCODER OR A PROBLEM FURTHER DOWN THE LINE TO THE MAIN PROCESSOR BOARD...IN 90% OF THE TIME IT WILL BE THE ENCODER....IF YOU HAVE ANOTHER ONE...ALL ENCODER BOARDS ARE THE SAME PART # MEB 1000 YOU CAN TRY REPLACING THE BOARD AND TEST AGAIN IF THE PROBLEM APPEARS NOT TO BE IN THE ENCODER BOARD THEN SEE PHOTO'S BELOW FOR FURTHER TESTS....

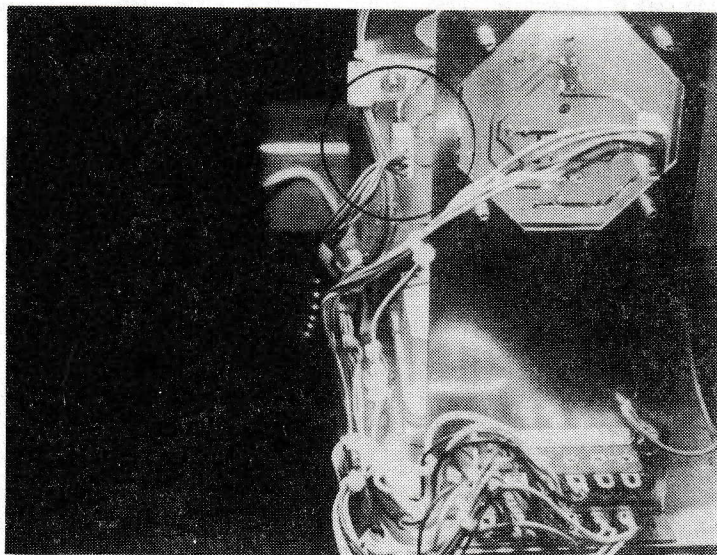
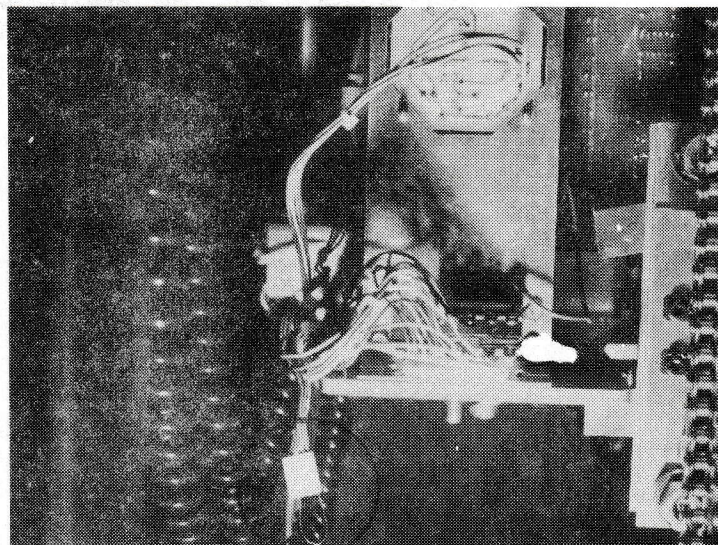
PHOTO (4)

IF YOU SHORT THE GREEN WIRE TO THE BLUE WIRE...THAT IS THE SIGNAL GOES TO GROUND...PHOTO (4) YOU SHOULD SEE THE HOME SIGNAL YOU ARE TESTING GO TO -YES. IF IT DOES IT PROVES THAT THE PROBLEM LIES IN THE ENCODER BOARD AND OR THE CONNECTION. THE SIGNAL WIRE ON THE Y-HOME ENCODER IS WHITE WITH BLUE STRIPE.

plug in rear of x-home encoder

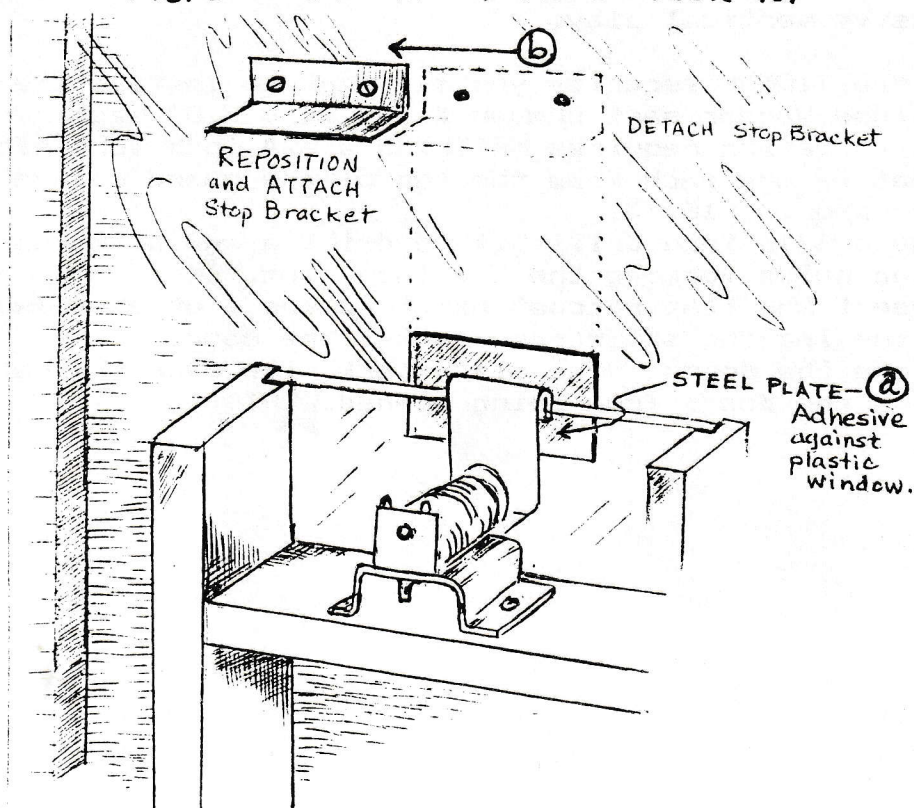
FIG. 1 REAR VIEW OF ACCESS DOOR TOP

1. Open the large lexan door (tape storage compartment) and the large rear door.
2. See FIGURE 1: Rear view of access door top.
3. The enclosed stainless steel plate has a special high strength adhesive applied to the lower half of one side. (Be careful, due to its thinness the steel plate has sharp edges.)

4. Peel off the adhesive protective paper and insert the plate between the plastic access door and the cabinet wall, adhesive side toward the plastic door, centered on the latch. See FIG. 1a. Position the plate so that the adhesive layer is just below the top of the plastic door and is approximately level. Now press the plastic door against the steel plate. Hold firmly for five seconds.

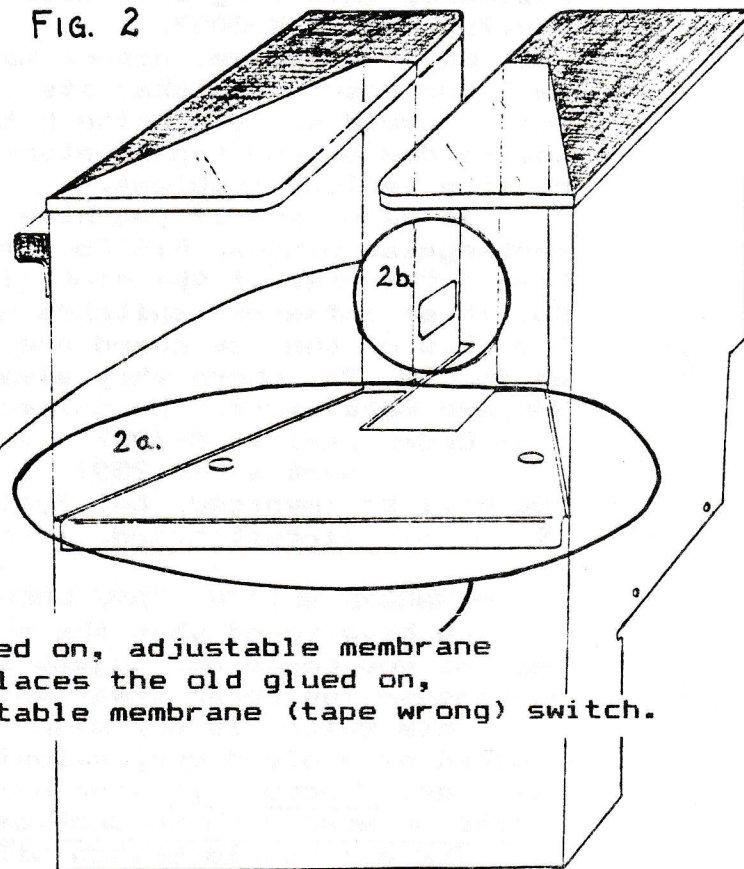
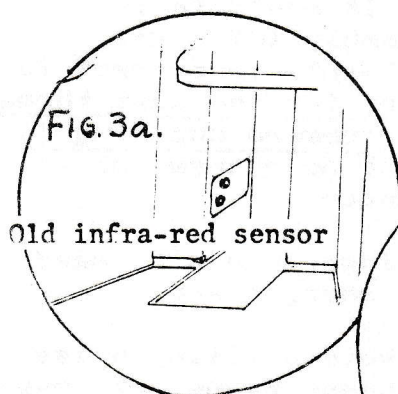
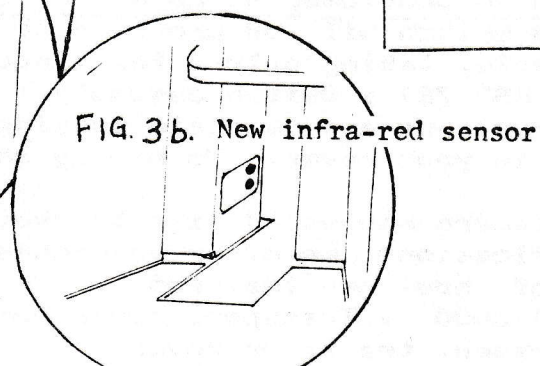
Either the mechanical sensor or the infra-red solid state sensor with the LEDs in the position shown in 3a (closest to the lexan doors), should be replaced with the newest version of the tape top sensor. It has LED (light emitting diode) sensors in the position shown in 3b (closest to the tape shelves).

To determine if you have this type of sensor, look into the rectangular window, FIG 2b. If the LEDs are angled and positioned toward the rear of the slot (lexan door side) as in FIG. 3a, you do. These infra-red switches will now be replaced at no charge. The LEDs on the new board are positioned toward the tape shelves as in FIG. 3b, where they always look at the front edge of both VHS and Beta tapes. No soldering or cable changes are necessary.

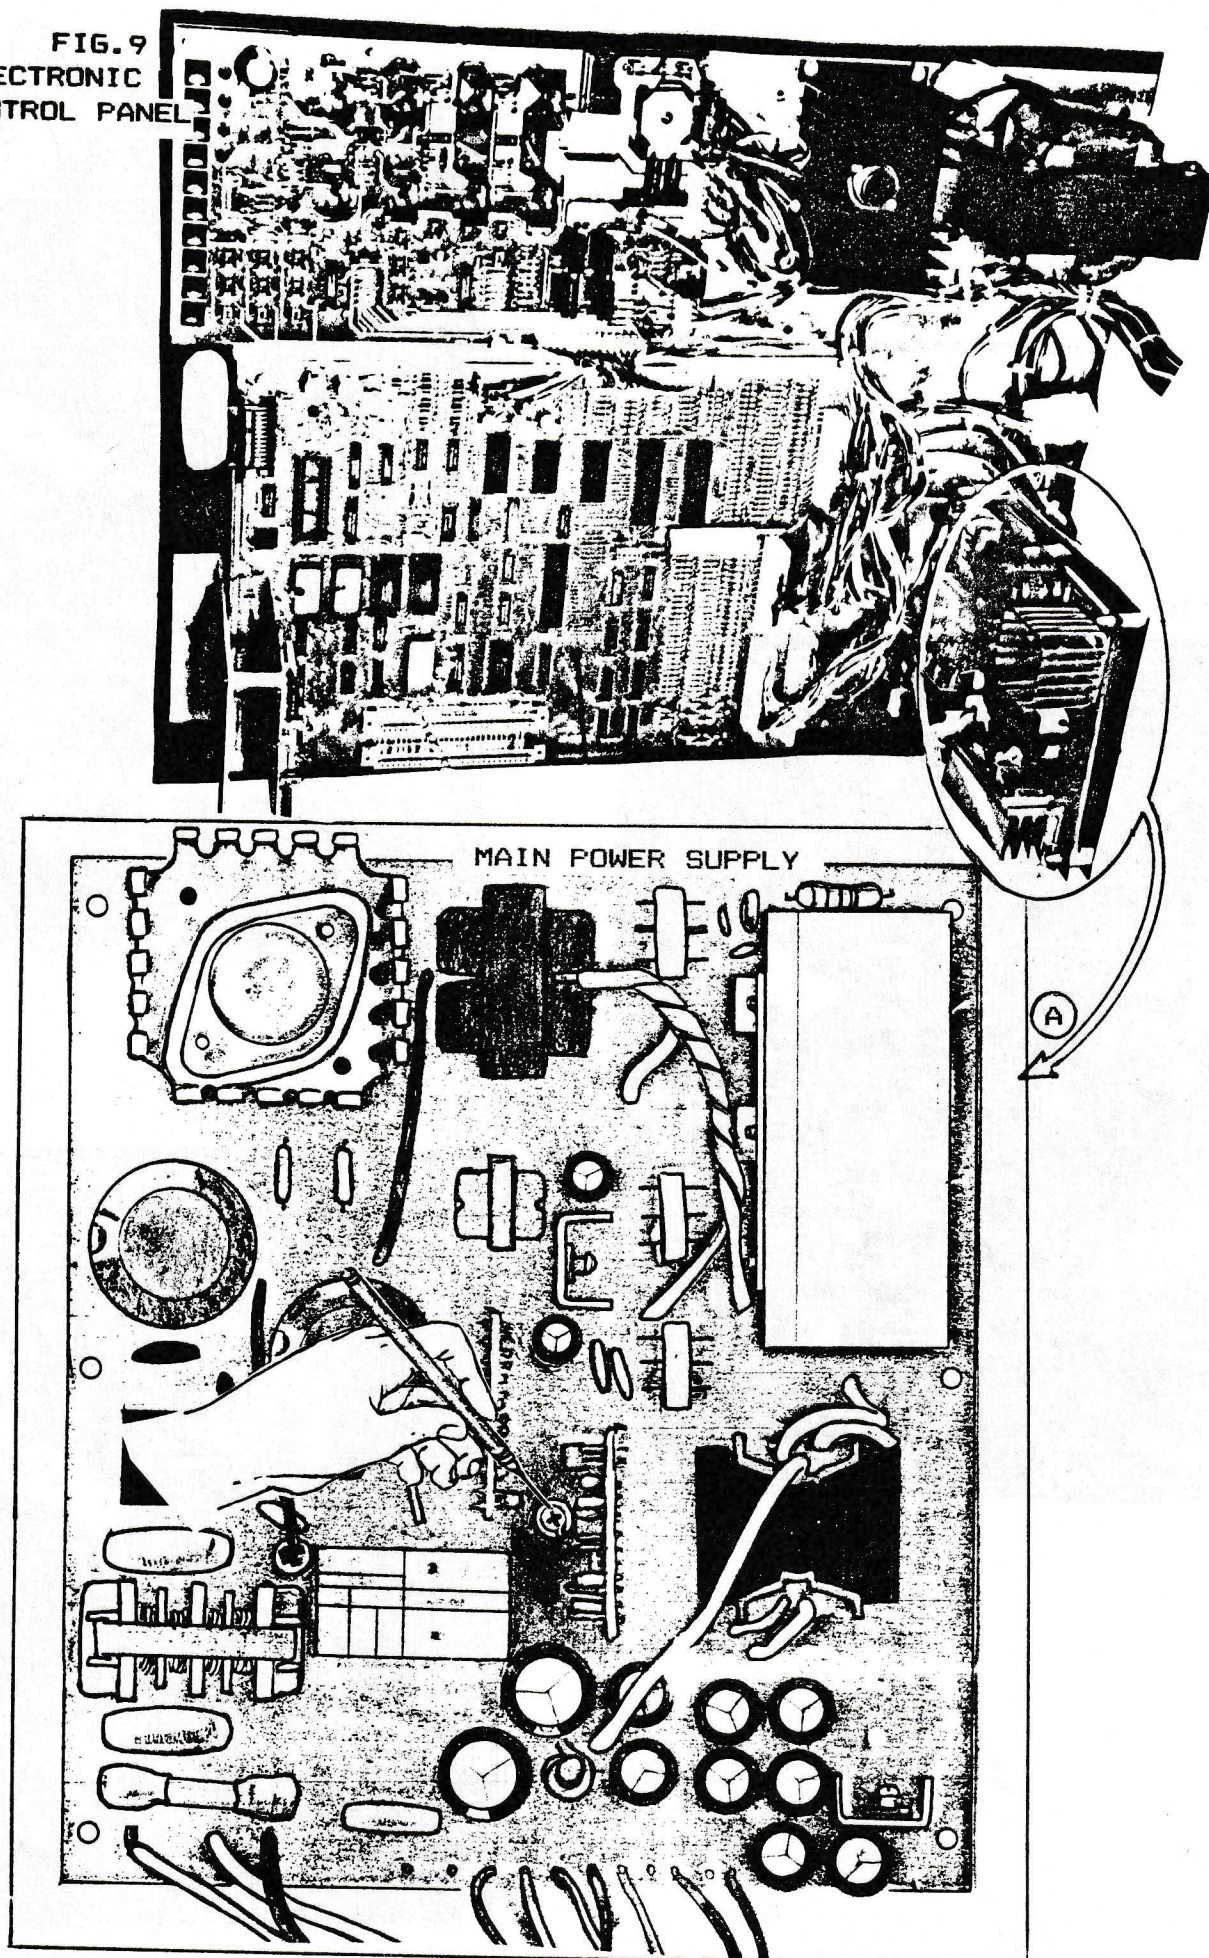
FIG. 9
ELECTRONIC
CONTROL PANEL

IF YOUR ACTUAL READINGS FALL 5% ABOVE OR 5% BELOW THESE AVERAGE READINGS, THEN YOU MUST ADJUST THE MAIN POWER SUPPLY. See Fig. 9 "A". Adjust clockwise or counterclockwise while paying CLOSE ATTENTION to your voltmeter.

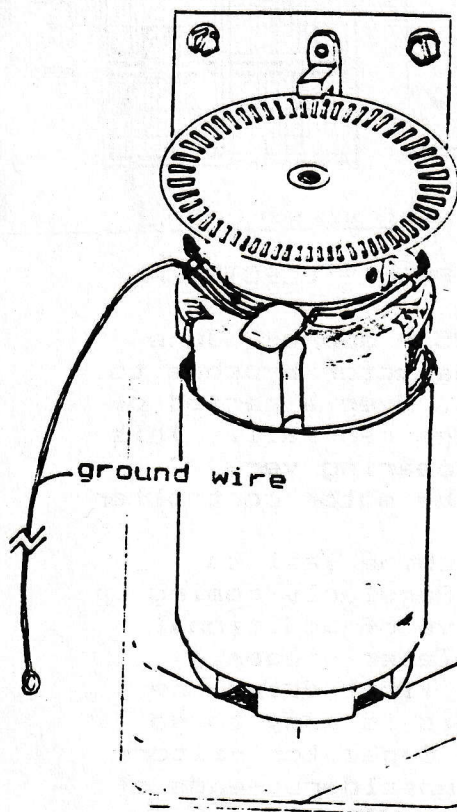
FIG. 1

Video Vendors manufactured from Nov. 1985 - approx. June 1986 were equipped with Zener diodes across the motor brushes to reduce the brush electrical noise (See FIG. 1). Over a period of time, we have discovered that these Zener diodes can fail. This failure usually results in the drive motors appearing very sluggish or in the fuse (3 amp Slow Blow) on the motor controller board (MCB 1000) blowing out.

On rare occasions you may only see the machine fail to retrieve a tape, coming up short of the slot. Regularly coming up short of the designated slot could be indicative of additional pulses being added to the counters due to the Zener diodes.

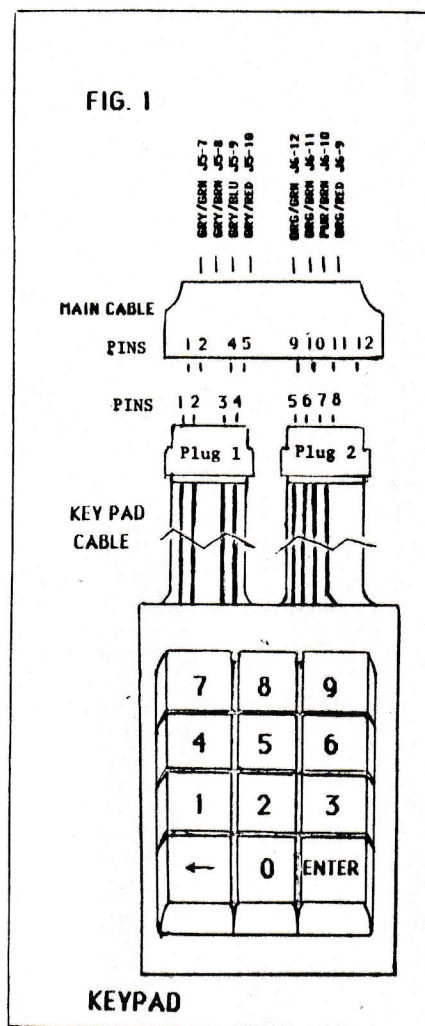
Here are three descriptions of the internal wiring and workings of the Keypad. Fig. 1 shows the basic layout of the key pad, connectors and wiring. If you suspect that a key on the keypad is not working, you can use the following information to check it out.

Fig. 2 is a matrix of the pins as they correspond to the Key Pad keys. Fig. 3 is the chart of outputs for checking continuity when a key is being depressed. All tests on the key pad should be made statically with the power to the machine shut off. The continuity checks are made with an OHM meter connected between the pins indicated in Fig. 3's chart. For each Key on the Keypad depressed you should read continuity on the OHM meter between the keys indicated. If no continuity is measured the Keypad is bad and should be replaced.

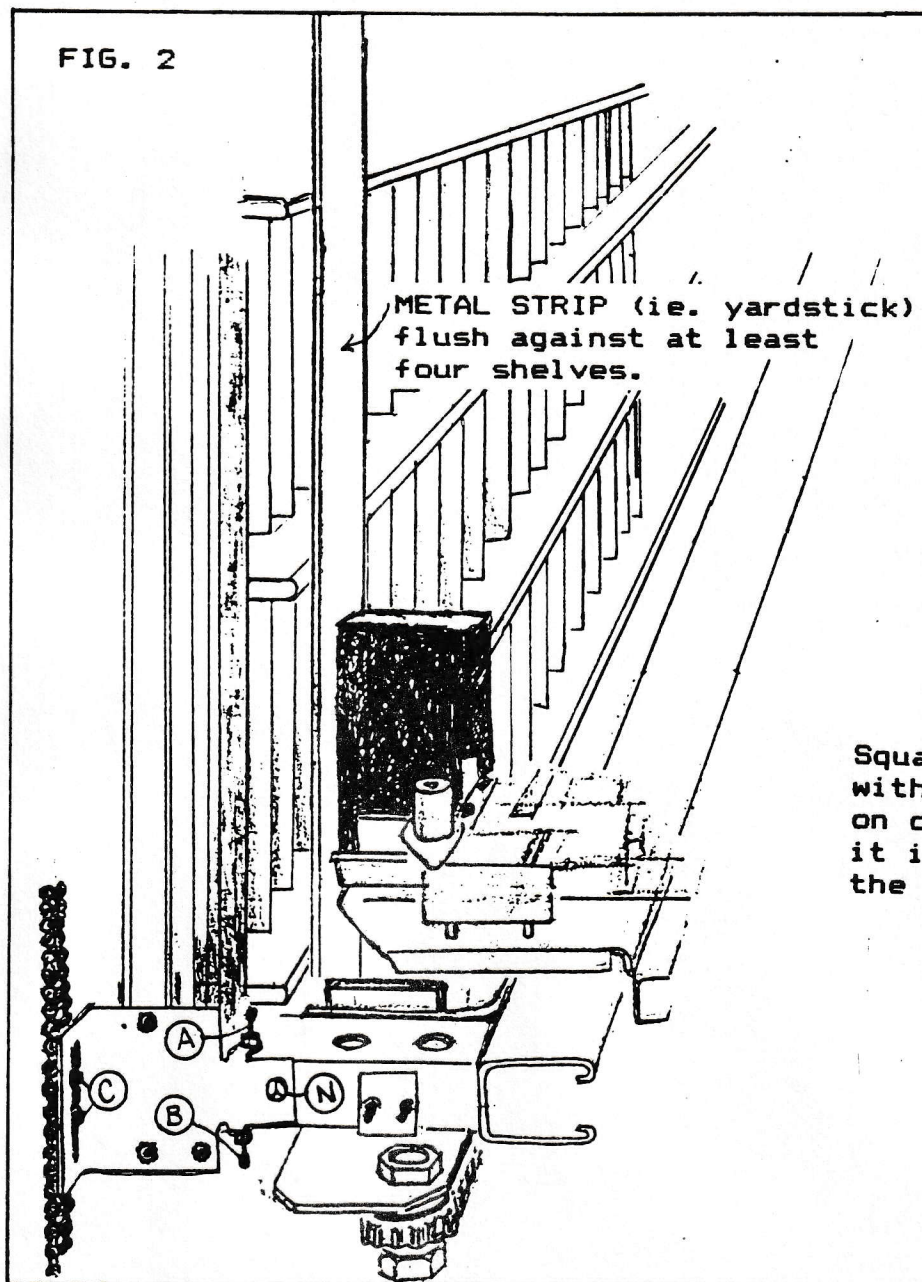
- b) top touches the metal, but there is a gap between the metal and the BOTTOM OF THE CASSETTE; Loosen locknut (N), loosen the locknut on (A), loosen the screw (A), loosen the locknut on (B) and tighten the screw B until position of the rail allows no gap between the test tape and the metal yardstick. Snug up screw A and tighten all locknuts: (A), (B) and (N).

- c) bottom touches the metal, but there is a gap between the metal and the TOP OF THE CASSETTE; Loosen locknut (N), loosen the locknut on (B), loosen the screw (B), loosen the locknut on (A) and tighten the screw (A) until position of the rail allows no gap between the test tape and the metal yardstick. Snug up screw (B) and tighten all locknuts: (A), (B) and (N).

- b) pointing ABOVE the mark, adjustment is made while supporting the horizontal rail. Loosen the chain screws (FIG. 2 detail (C)) gently allowing the rail to lower slightly until the retriever arrow points to the mark on the test tape. Retighten the set screws in this position.
 - c) pointing BELOW the mark, adjustment is made while supporting the rail. Loosen the chain screws (FIG. 2 detail (C)) gently raising the rail until the retriever arrow points to the mark on the test tape. retighten the set screws in this position.
7. Test the machine. If it is functioning properly, close and lock doors and resume rental mode of operation.

NOTE: Whenever it is necessary to make these adjustments to the horizontal rail, the X- and Y-Counts should be rechecked (see Service Bulletin #16).

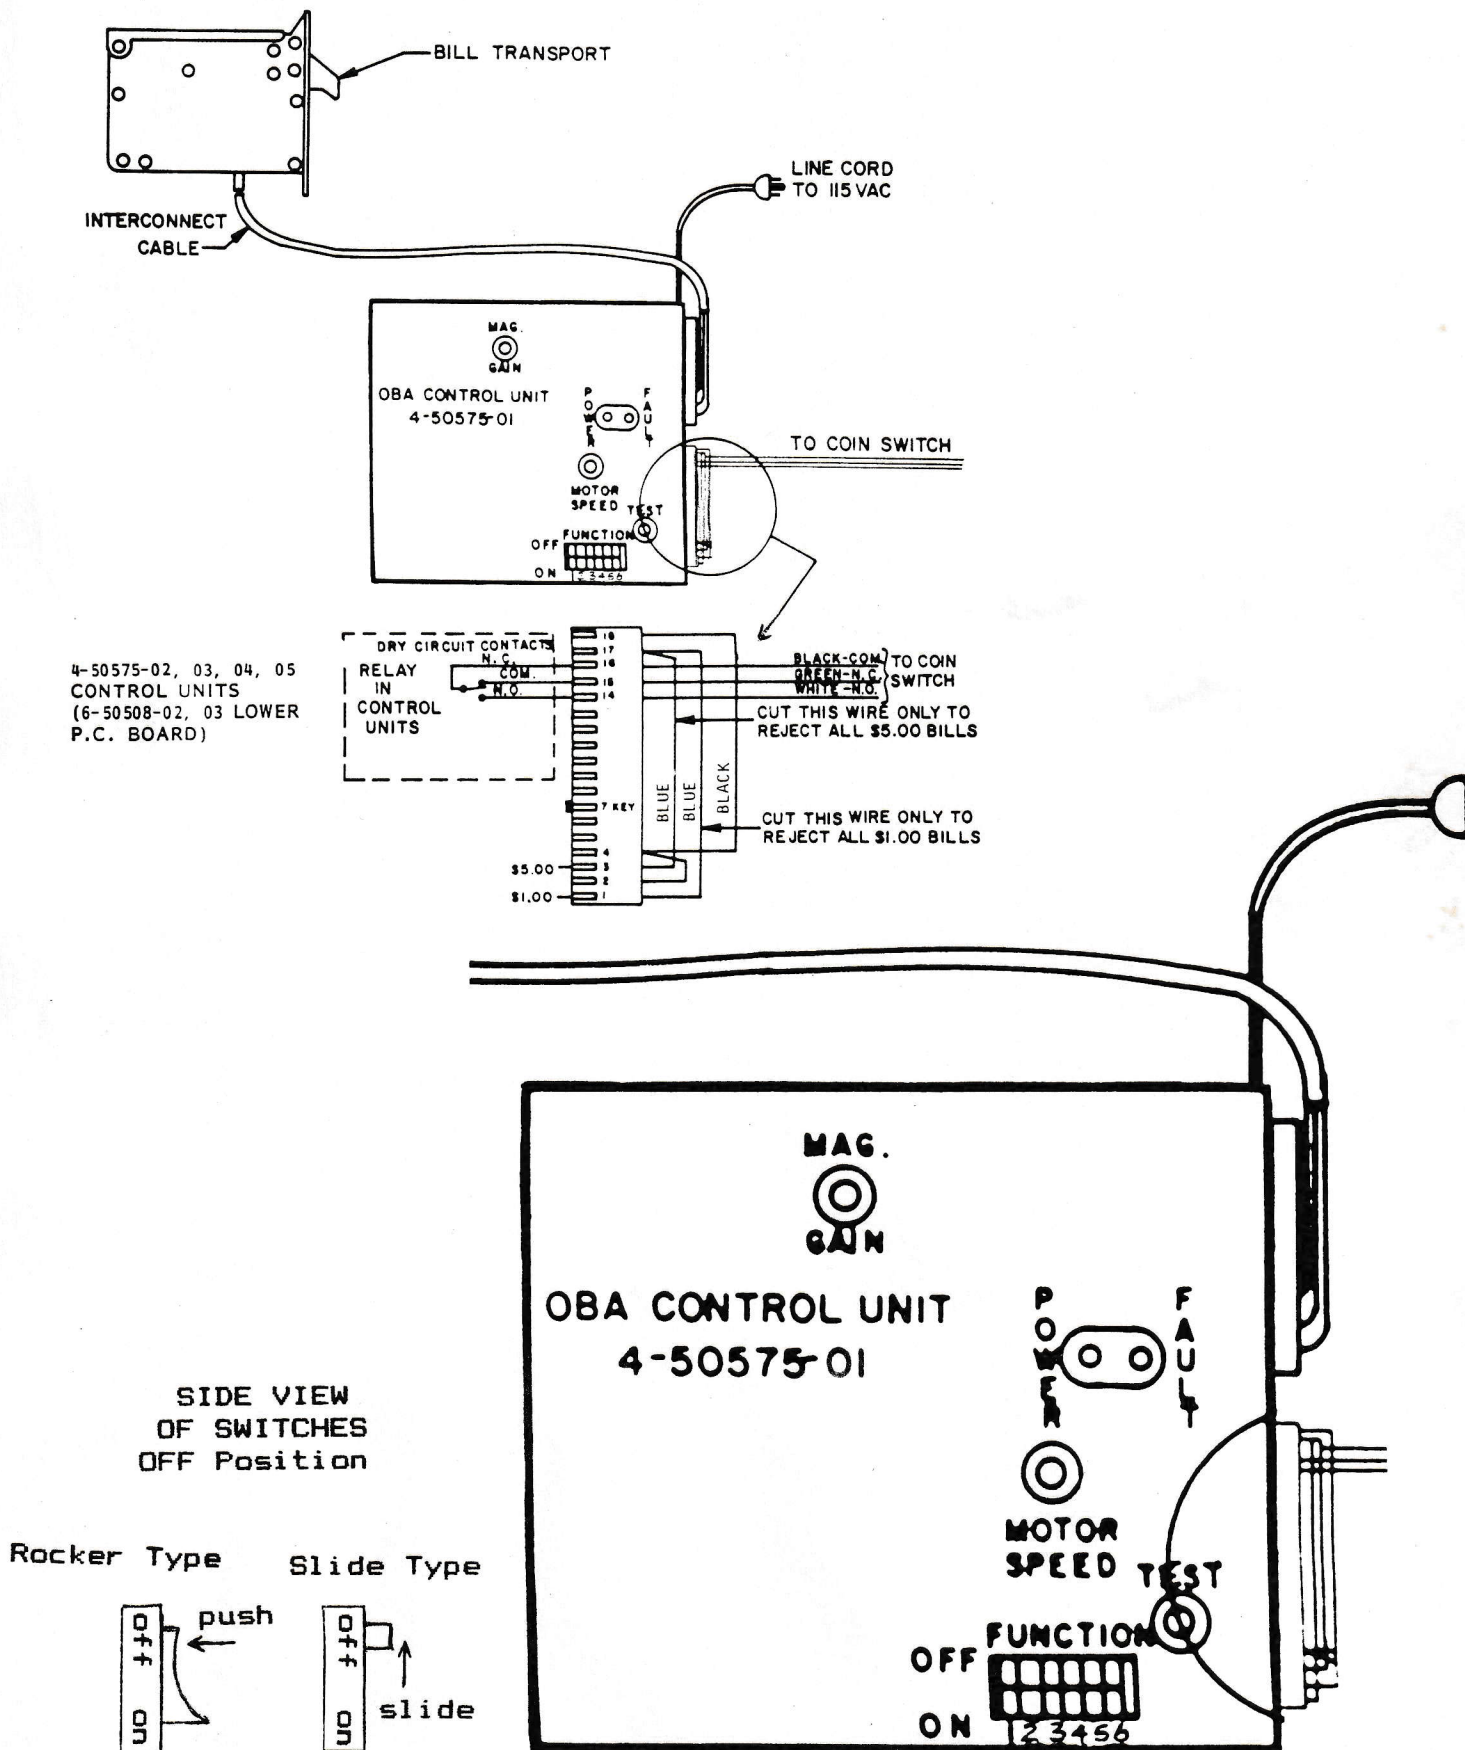
FIGURE 1

The following instructions are for the adjustments to be made on your O.B.A. unit **ONLY** if it is not working (fails to accept \$1 and \$5 bills). **DO NOT** perform these adjustments if your O.B.A. unit is functioning properly.

If your OBA still has trouble accepting one dollar bills, we have found that a slight increase in motor speed (clockwise direction) over the correct setting, clears up that problem.

Do not overlubricate.

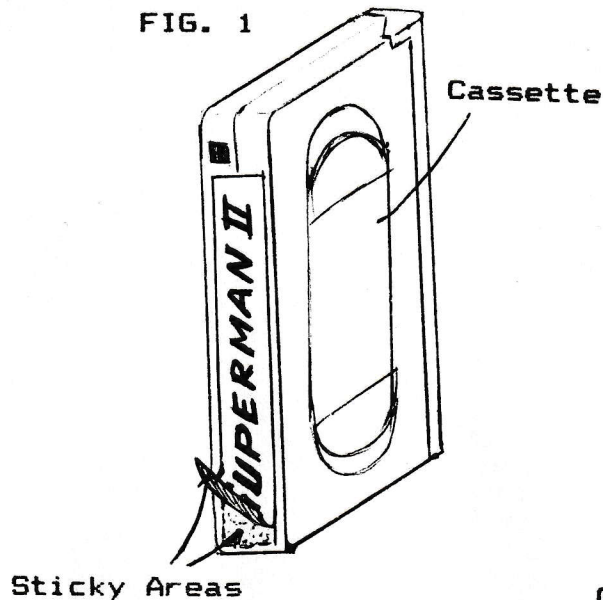
FIG. 1

We have noticed that the Title Labels on the spines of cassettes can begin to peel up (See FIG. 1) and can cause retriever "Error 99" problems.

The corrective action is to inspect your tape inventory and replace all stickers or Title Labels that appear loose before they become a problem.

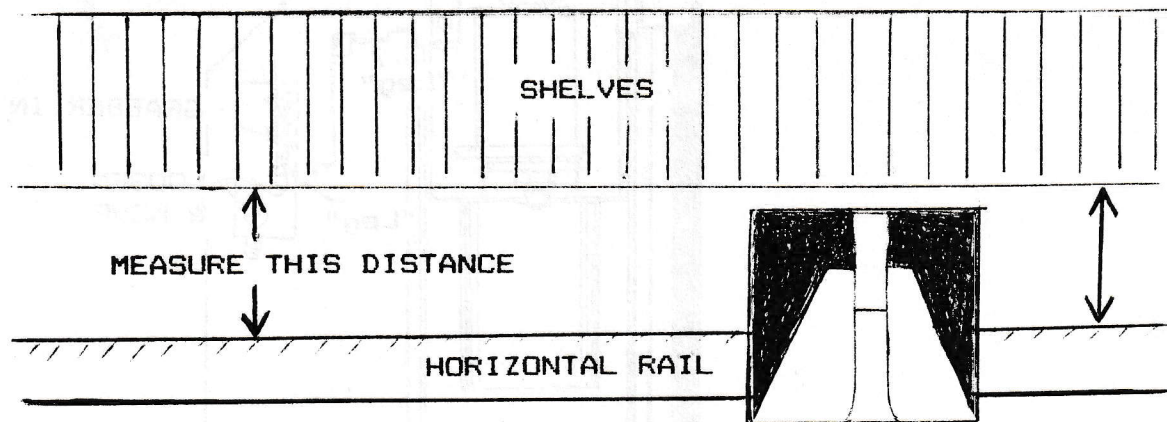
FIG. 1

The "Grabber In" switch can only be adjusted properly in only ONE place in the machine. That is the shelf location where the horizontal beam is at the closest distance to a shelf (See FIG. 1). You will have to move the bar in front of all eight shelves and measure each to find the location where the bar is closest to a shelf. Once you have found the closest point, that will be the location where you will adjust the "grabber in" micro-switch.

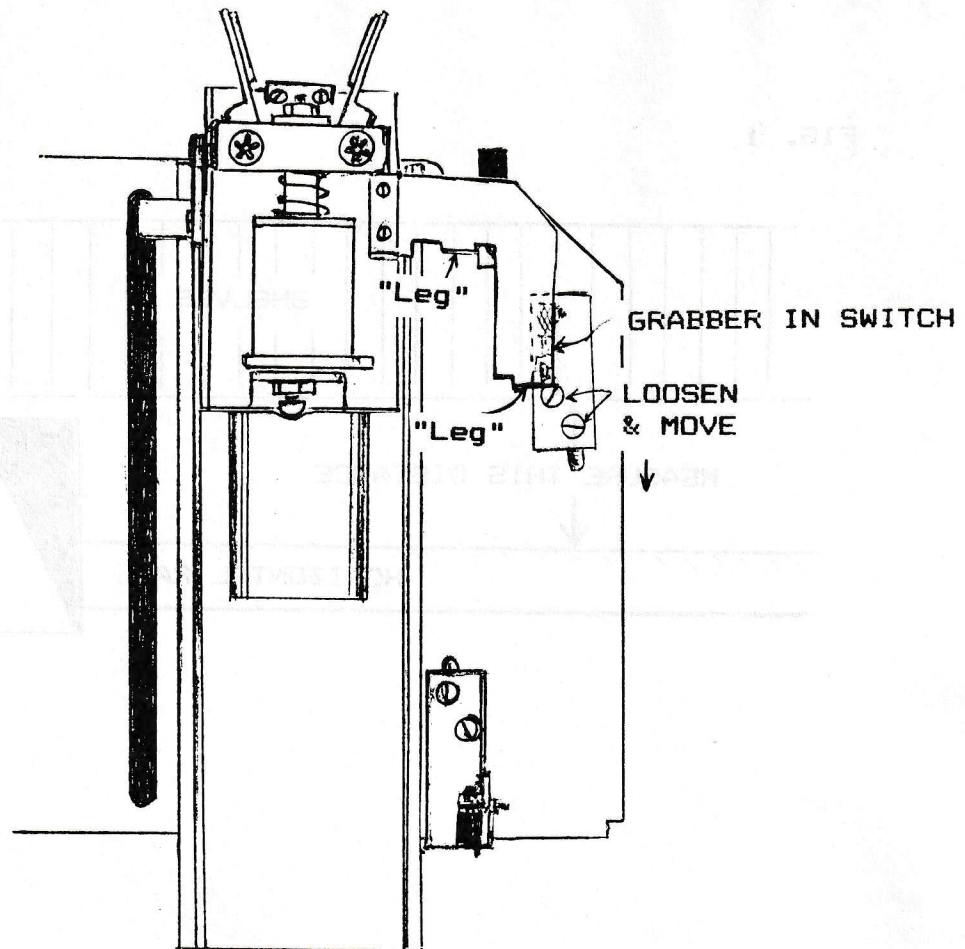
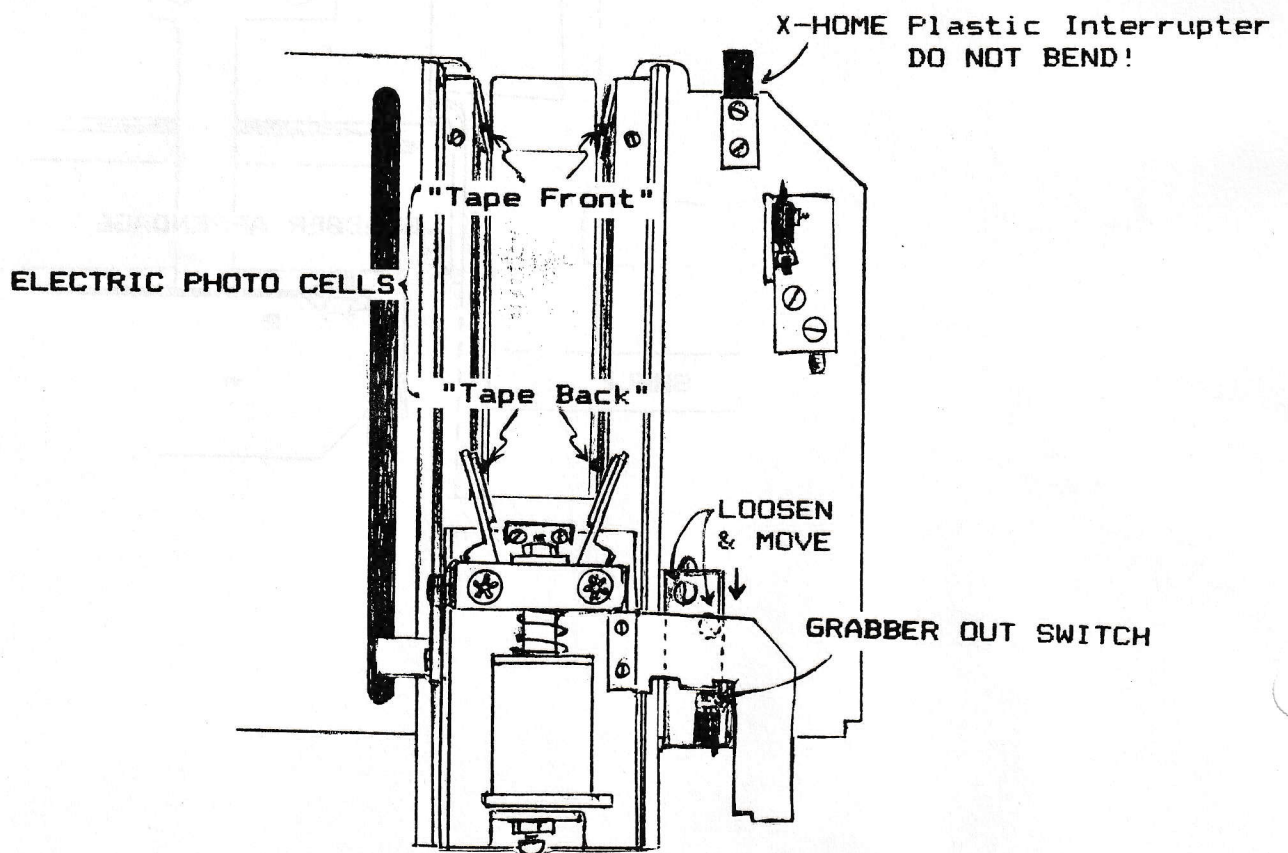
The grabber "In" and "Out" switches are located inside the Retriever's stainless steel, box shaped housing. To uncover the grabber switches, you must first move the retriever to a convenient location in the machine. To do this, open the top service door and enter Feature #19, Diagnostics. Run the retriever up to location #150. Open the Lexan doors. Remove the four screws from the sides of the retriever cover (two on each side). Turn OFF the AC power. Carefully, lift off the cover and note how the wires are tucked under the Z Motor housing. Unplug (by pulling apart) the white connector on the wires between the retriever and its cover. You can now completely separate the retriever cover from the retriever mechanism which will expose the grabber "In" and "Out" switches. See FIG. 3 & 4.

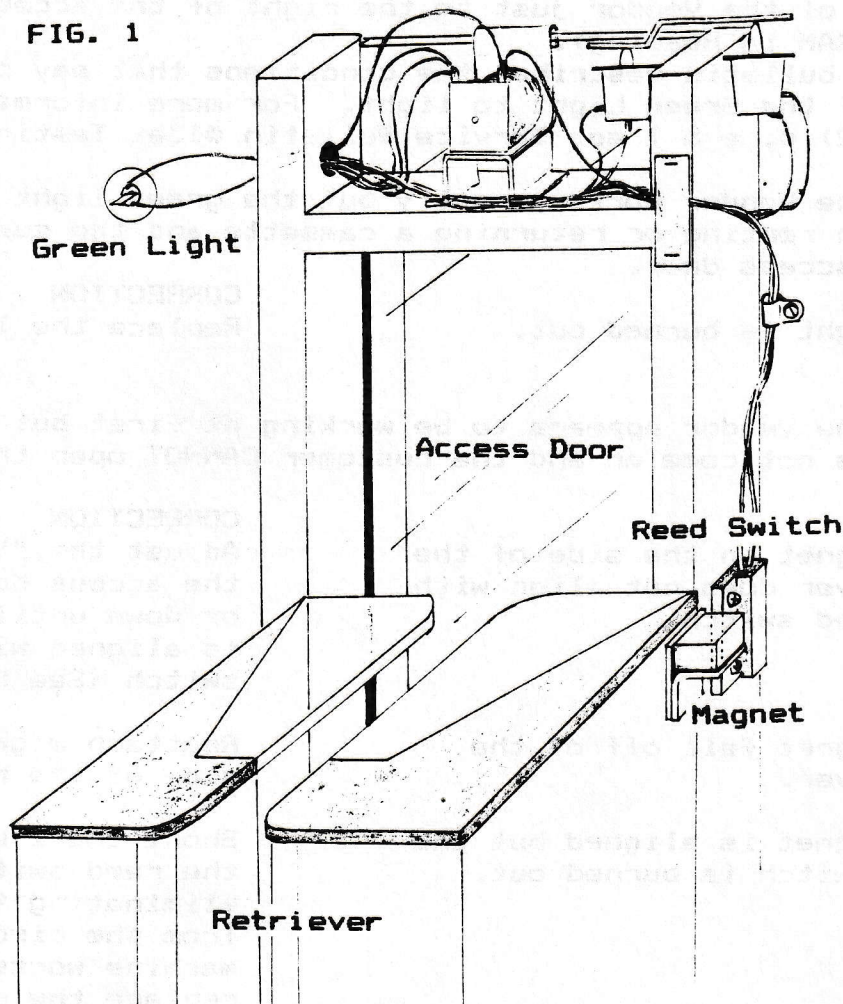
FIG. 1

c) The magnet is aligned but the reed switch is burned out.

Short the 2 wires on the reed switch together eliminating the switch from the circuit. If the machine works properly replace the reed switch.

Check the output of J3 Pin 6 to see if it goes to ground potential when the access door is activated with the "door" button on the MCB. If it does not, replace the Motor Control board.

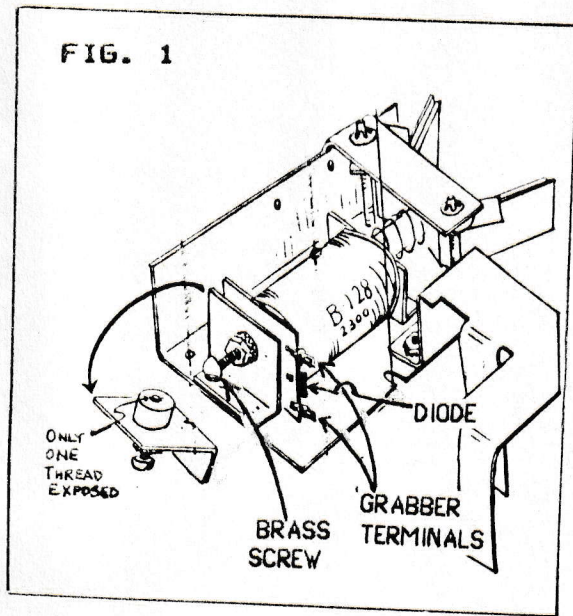
FIG. 1

1. GRABBER FAILS TO CLOSE.
 - (A) NO VOLTAGE AT GRABBER TERMINALS. SHOULD BE AT LEAST 19 VOLTS. (FIG. 1)
 - (B) CHECK DIODE ACROSS GRABBER TERMINAL FOR SHORT. PARTICULARLY IF YOU BLOW THE FUSE WHEN THE GRABBER CLOSSES. (FIG. 2)

- (E) CHECK THAT GRABBER TERMINALS ARE NOT TOUCHING ANY METAL SURFACE. (FIG. 1)
2. CASSETTE SLIDES OUT OF GRABBERS GRIP.
 - (A) CLEAN GRABBER PADS WITH DENATURED ALCOHOL SOLUTION OR REPLACE GRABBER PAD IF WORN.

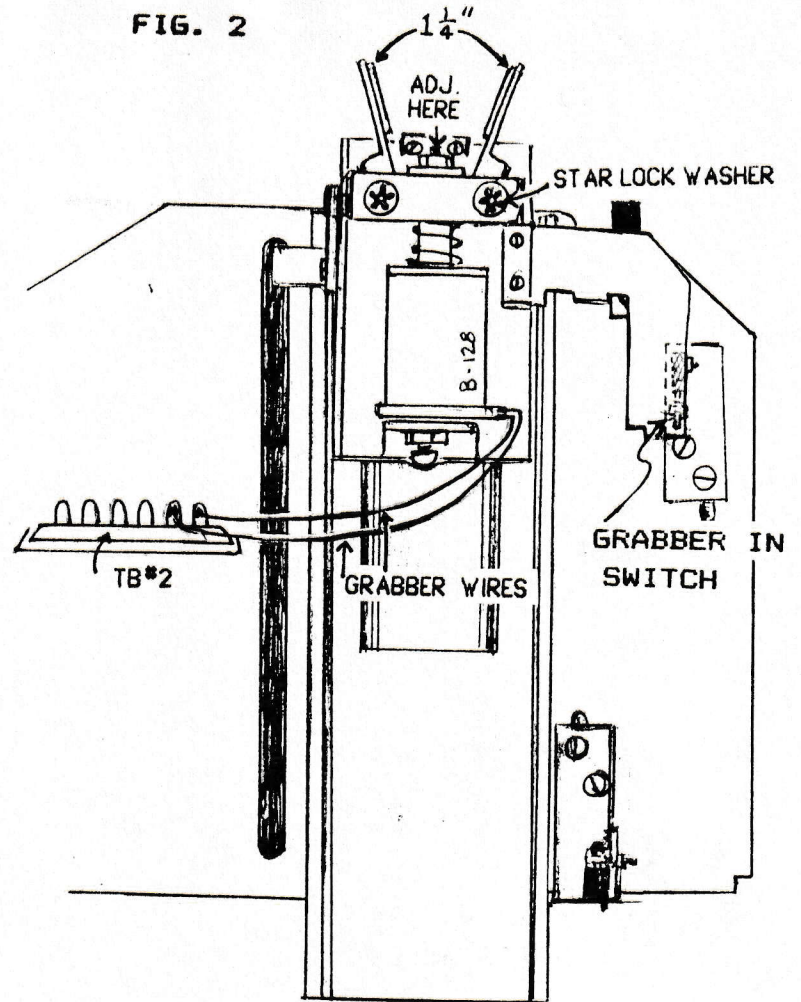
FIG. 2

3. GRABBER RELEASES INTERMITTENTLY FOR NO APPARENT REASON.
 - (A) REPLACE GRABBER WIRES BETWEEN GRABBER & TERMINAL (FIG. 2).
 - (B) CHECK GAP BETWEEN INSIDE DIMENSION OF GRABBER PADS. SHOULD BE 1 1/4". (FIG. 2)

(B) CHECK FOR MECHANICAL BINDS CAUSED BY THE STAR LOCK WASHER COMING OFF THE PIN HOLDING THE GRABBER IN PLACE. (FIG. 2)
5. GRABBER FIRES TO EARLY AND DOES NOT GET THE CASSETTE OFF THE SHELF. (A) THE GRABBER IN MICRO SWITCH IS BAD GIVING A GRABBER IN SIGNAL TOO SOON. REPLACE SWITCH. (FIG. 2)
